Sample Home Inspection Report

HOME INSPECTION REPORT

Mr. and Mrs. Prospective Buyer

6543 Any Street

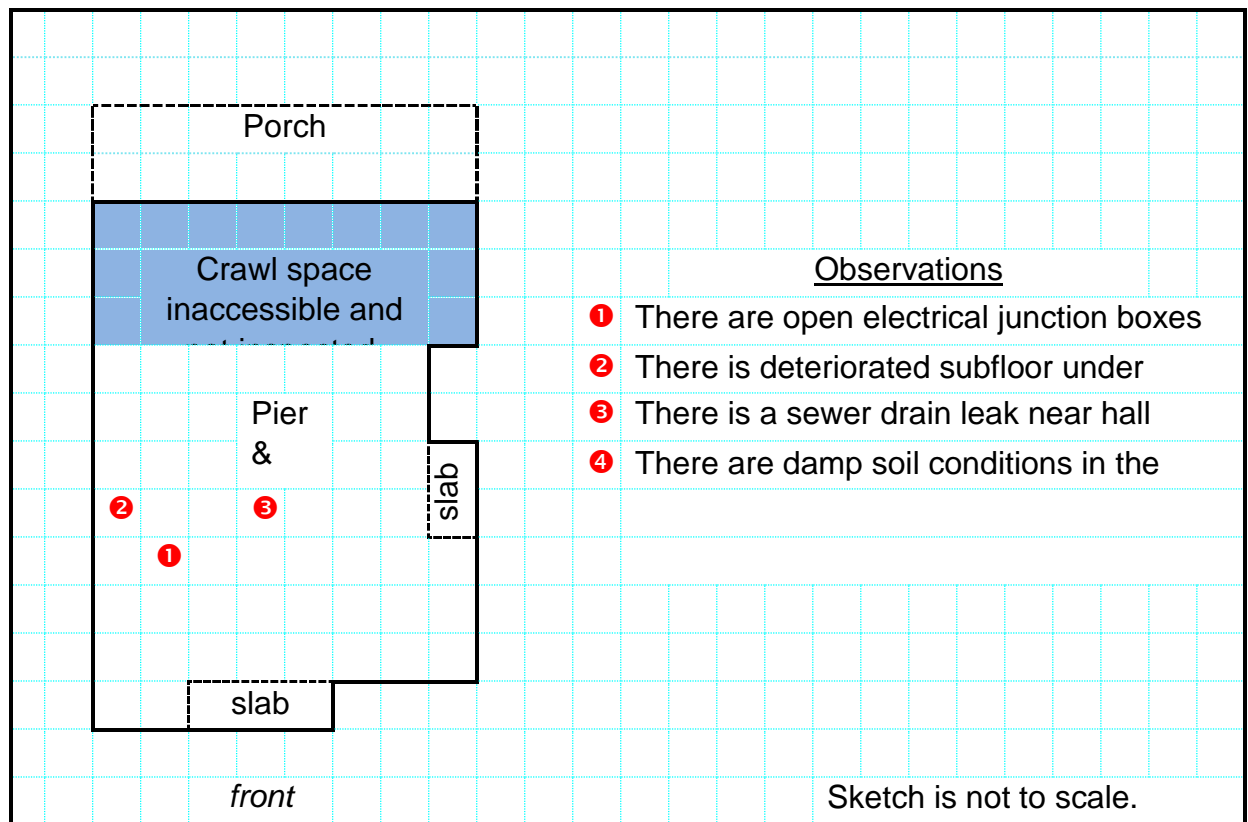
Beneath the house, there are multiple electrical lines and water and gas plumbing lines. Some of the electrical lines hang loosely, and there are old styles of wires, with "fabric" (*armored cable*) insulation some of which may be frayed or damaged. During the life of this home, the electrical system has *probably* been updated, and some of these older wires *may* have been abandoned. The electrical system is likely to be a combination of

original and updated wiring. This wiring beneath the house can be hazardous, and caution is urged in dealing with the electrical system of this house.

The galvanized plumbing lines are rusted, and the cast iron drains are a brittle material, presenting a leakage potential. The plumbing system appears to have been updated and/or repaired with PVC drain lines and copper and plastic water supply lines observed beneath the house as well. Particular locations of observed leaks in the plumbing system observed have been recorded in the inspection report summary, however under certain conditions, other leaks may be present.
